EXCAVATION SHORING FAILURE THREATENS A HISTORIC CHURCH: EXPLORATION OF CAUSES AND REMEDIAL MEASURES

ABSTRACT

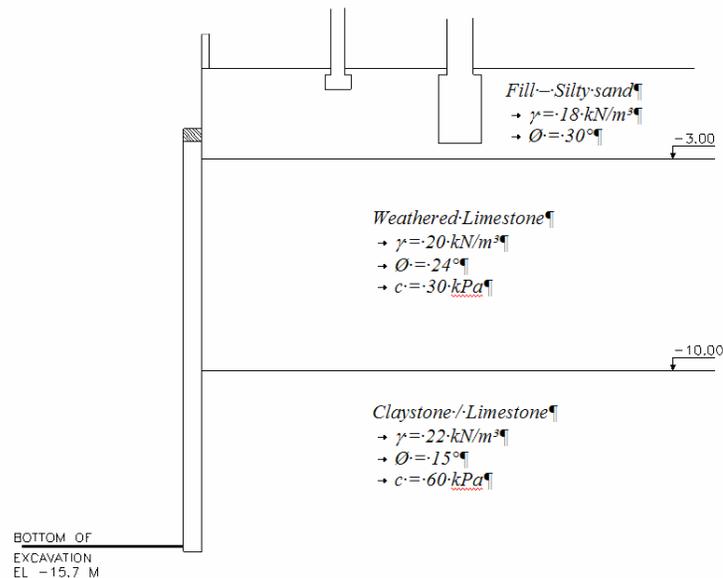
Fig. 2. Typical soil profile and design characteristics

A comprehensive site investigation campaign was initiated and a geotechnical report prepared by Turba Engineers in May 2000. In total, seven boreholes and a number of test pits were executed within the church grounds alone. The deduced stratigraphy at the site is presented in Fig. 2 along with the soil parameters used for the design of the remedial shoring and underpinning works. The soil profile consists of:

- A surficial layer of red-brown clayey sand, 2m to 6m thick. The clayey sand layer is loose to dense with SPT values ranging between $N=5$ and $N=7$.
- A layer of creamy white weathered marl, moderately firm to firm, 3m to 8 m thick.
- Green-gray claystone and creamy white limestone firm to very firm.

Water was found in the boreholes at a depth of -12m to -13m . It is important to add that during the initial excavation works, water influx into the site was reported at much shallower depths, probably seeping from localized sources, likely broken utilities.

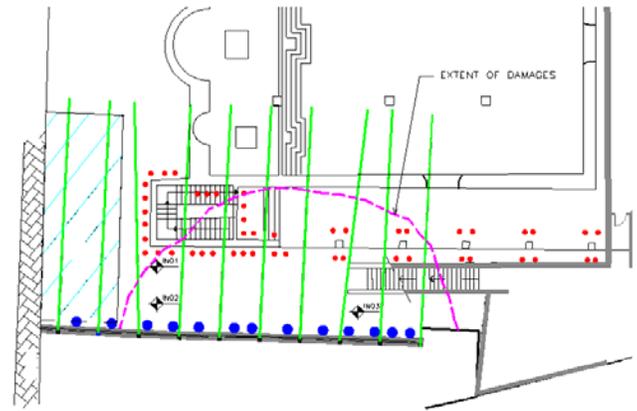
Fig. 3. Extent of “failed zone” and micropile layout

Based on the comprehensive damage survey prepared for the structure, the areas of extensive damage appeared to be concentrated in the zone identified in Fig. 3. The damage patterns and the established subsurface conditions strongly suggest that the distress to the structure is due to a loss of soil and bearing support beneath the church foundations. The loss of support may be associated with lateral deformations of the shoring system at the excavation limit. The foundation system in this case consisted simply of shallow (1-2m) “piers” built with sandstone blocks and bearing on the sand layer for some and the underlying marl for others. As such, the remedial solution adopted for the church itself was to consolidate/strengthen the bearing soil and then strengthen the church walls.

Given the above, the underpinning system was modified to include low-capacity vertical and inclined micro-piles installed in a relatively dense array around the church foundation piers and footings. The micro-piles were designed provide support for the applied the vertical loads while at the same time consolidating the subsurface soils. Pre-jacking was not considered since it

The layout of the micro-piles is presented in Fig. 3. It is basically comprised of two schemes. Four battered micro-piles are installed in an “X” pattern around the external 30-t columns, at a 15 degree to the vertical, as shown in Fig. 4. The micro-piles were positioned outside the walls of the staircase given the extremely tight space inside. The top of the micro-piles were tied through a cap beam which connects through “finger” beams (openings made through the external walls) to an internal mat constructed inside the staircase. The layout of the micro-piles was finalized in such a way as to minimize any interference with the future pre-stressed anchors of Lot 235.

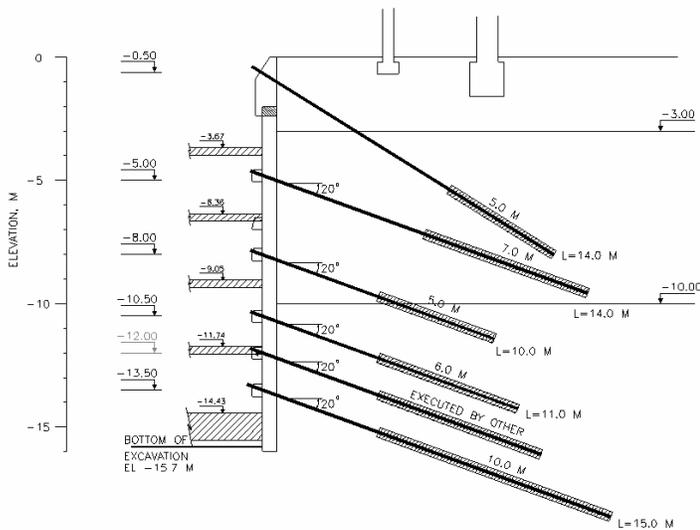
Fig. 6. Layout of the re-designed shoring system along lot-235

In total, five rows of anchors were executed as shown in Fig. 6. The moment capacity of the piles was verified but large deformations remained at the pile toe despite increasing the number of anchors and lowering the last row of anchors. The reason for these large deformations was attributed to the insufficient pile embedment. A decision was taken to accept the calculated toe-level deformations at the design stage with the provision that the piles would be locally examined and treated once the final excavation level is reached.

A new concrete wall was constructed above the existing piles and the first row of anchors placed through it as shown in Fig. 6. This row was provided as a key element in controlling top deformations.

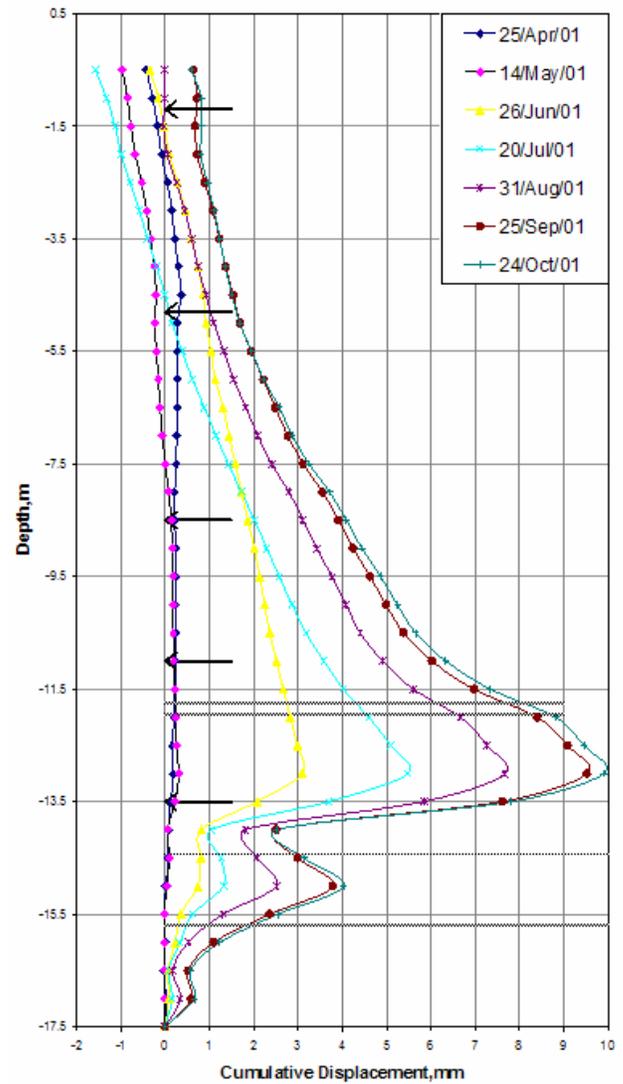
Fig. 7. Cumulative displacements at IN02

- ❑ Deformations at the top remained small and less than 1 mm.
- ❑ Deformations at the bottom of the pile are relatively large, reaching a maximum of 10 mm.
- ❑ Deformations usually increase during excavations and either regress or stabilize after anchor installation.
- ❑ Deformations at top anchors are not affected by subsequent excavation stages.
- ❑ Once the final excavation depth was reached, deformations continued to evolve but at a slightly slower rate than during excavation.
- ❑ Once construction of the building foundations and slab started, the rate of deformations decreased significantly to become almost nil.

The above findings were generally anticipated based on the design. However, it is interesting to note that deformations continued even after a stable level of excavation was reached. Although the observed values were still smaller than predicted, the observed behavior was unusual and may be associated with one or a combination of the following:

- ❑ Lack of pile embedment, which gives rise to an unstable toe; or
- ❑ Delayed reaction of the shoring system due to a natural long-term relaxation of the soils in which the anchors are secured.

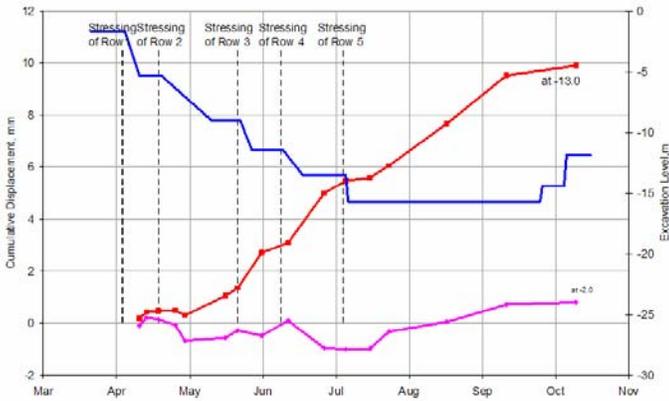
Fig. 8. Time displacements at IN02

The continued deformations measured along the excavation walls after the completion of the excavation and for a duration of weeks to months was unexpected. This was attributed to the nature of the subsurface strata and long term creep and relaxation of the anchors. All in all the deformations remained well within the levels anticipated.
