EXCAVATION SHORING FAILURE THREATENS A HISTORIC CHURCH: EXPLORATION OF CAUSES AND REMEDIAL MEASURES

ABSTRACT

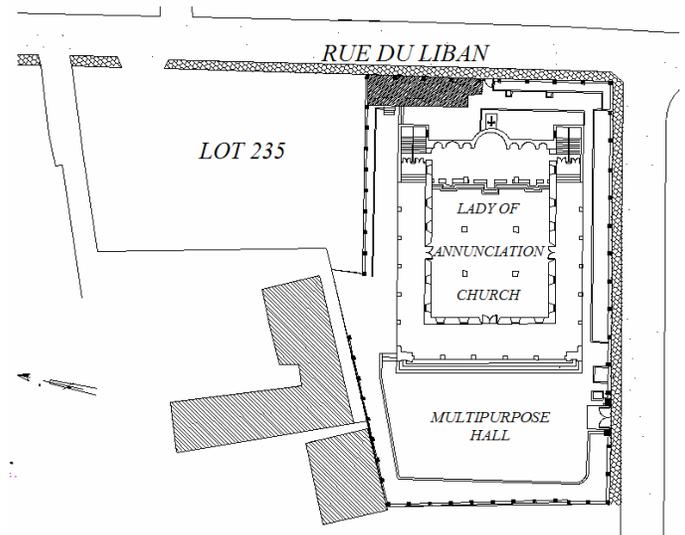
Fig. 1. General plan view of the church and lot 235.

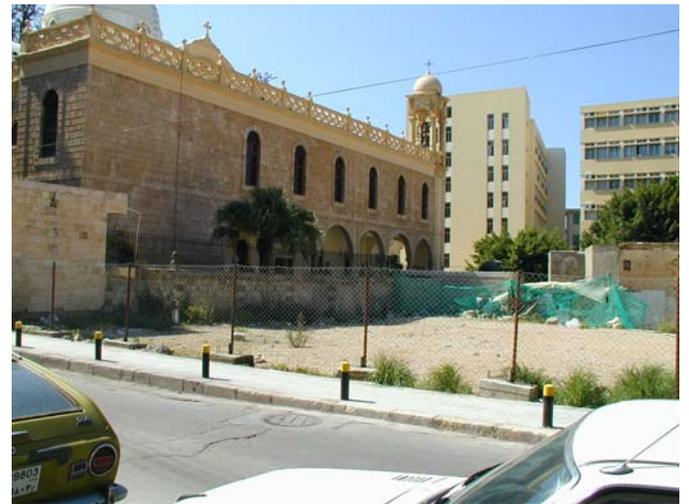
PS- As an interesting side note, after the re-excavation works were completed, the long standing legal disputes and costs incurred during the months leading to that point, the main contractor faced grave financial difficulties. Works on building the basements superstructure could not proceed and the lot was backfilled, again!, and serves now as much needed parking area for the neighborhood Fig. 9.

Fig. 9. View of the backfilled lot.
